Pavezzi Resisto Decking

**PRODUCT BAL29 TESTING
REPORT
AS 1530.8.1 - 2018**

IGNL-9295-16R I01 R00 D02

Tested: 27.08.2025

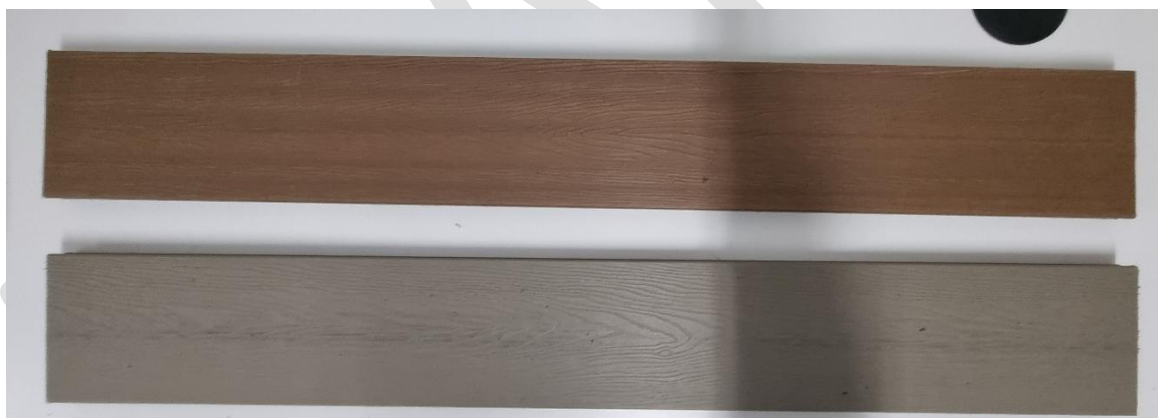
FIGURE 1:

The specimen was received as decking boards with one brown face and one grey face. The boards had measured dimensions of 995 mm in length, 137.39 mm in width, and 23.08 mm in thickness. Each board featured grooves along the long edge with measured dimensions of 2.01 mm in depth by 7.53 mm in width. Additionally, six cylindrical holes, each with a measured diameter of 13.26 mm, extended continuously along the entire length of the board. The decking boards were installed by using the slim metal clips and start and finish clips to maintain 3 mm spacings.

SPECIMEN RECEIVED

The specimen was received as decking boards with one brown face and one grey face. The boards had measured dimensions of 995 mm in length, 137.39 mm in width, and 23.08 mm in thickness. Each board featured grooves along the long edge with measured dimensions of 2.01 mm in depth by 7.53 mm in width. Additionally, six cylindrical holes, each with a measured diameter of 13.26 mm, extended continuously along the entire length of the board.

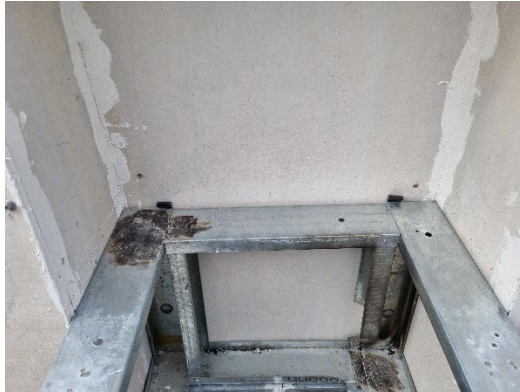
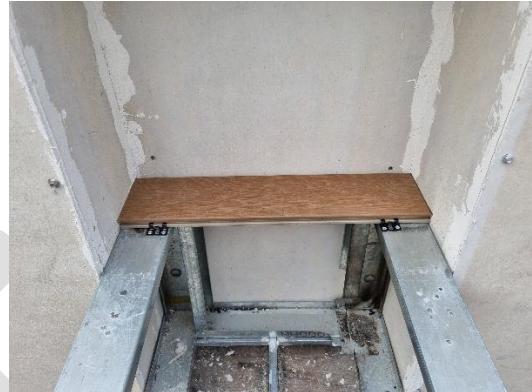
FIGURE 2:

SPECIMEN FABRICATION

The specimen was fabricated to the test dimensions by Ignis Labs. The boards were installed with the provided clips, with an approximately 3 mm gap between the boards. The boards were installed parallel to the main wall of the test rig, with the brown face oriented upwards. 10G 16 mm Metal Tek Screws were used instead of the provided wood screws as the boards were fixed to the metal frame in the test rig. The clips were positioned 80 mm from the end of the boards with a 440 mm spacing between the two clips. The final board was cut to a width of 48 mm and slotted in accordance with the installation guide.

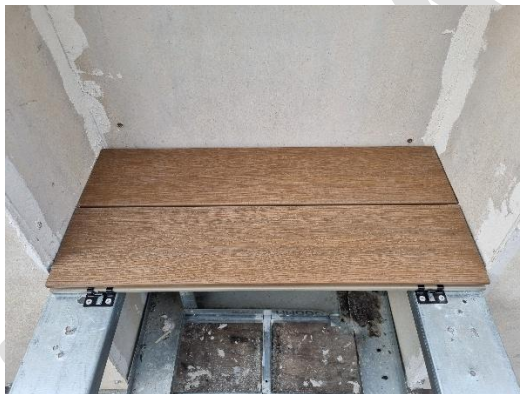
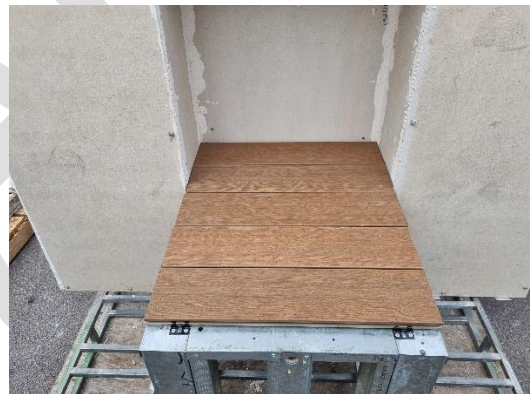
FIGURE 3:

SPECIMEN FABRICATION

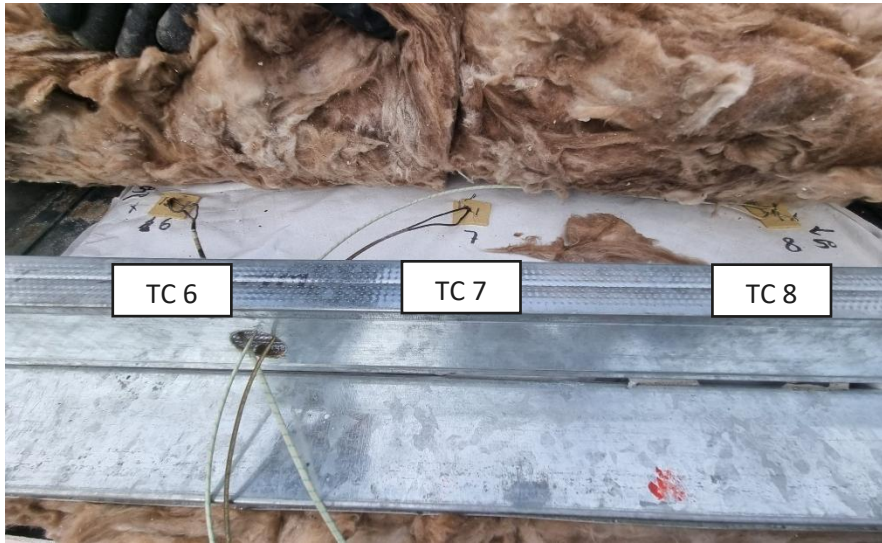
The temperature of the specimen including the joints was measured by glass-fibre insulated and sheathed K-type thermocouples with a wire diameter of 0.5mm.

Locations of the thermocouples on the unexposed face of the specimen are detailed below.

FIGURE 4:
THERMOCOUPLE INSTALLATION ON TOP CAVITY

The specimen temperature was monitored by the thermocouples distributed on the un-exposed face of the test specimen, as shown in Figure 4. All thermocouple temperature at the top cavity are within the mean and maximum temperature limits between 20 minutes and 60 minutes after the commencement of test.

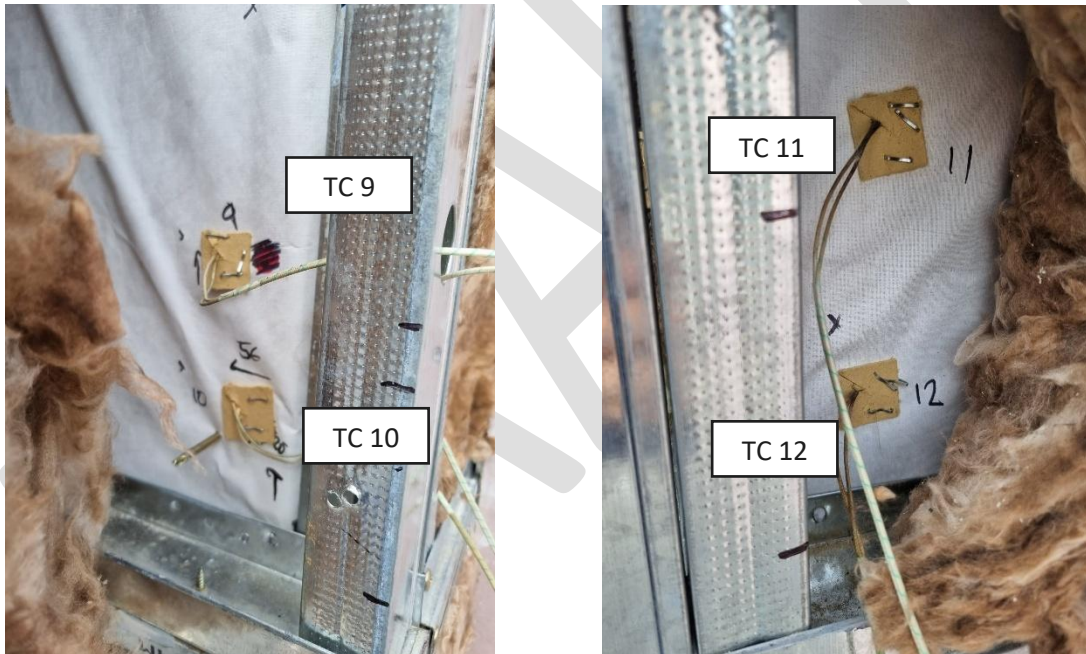
FIGURE 5:
THERMOCOUPLE INSTALLATION ON THE BACK CAVITY ON SIDE CAVITY

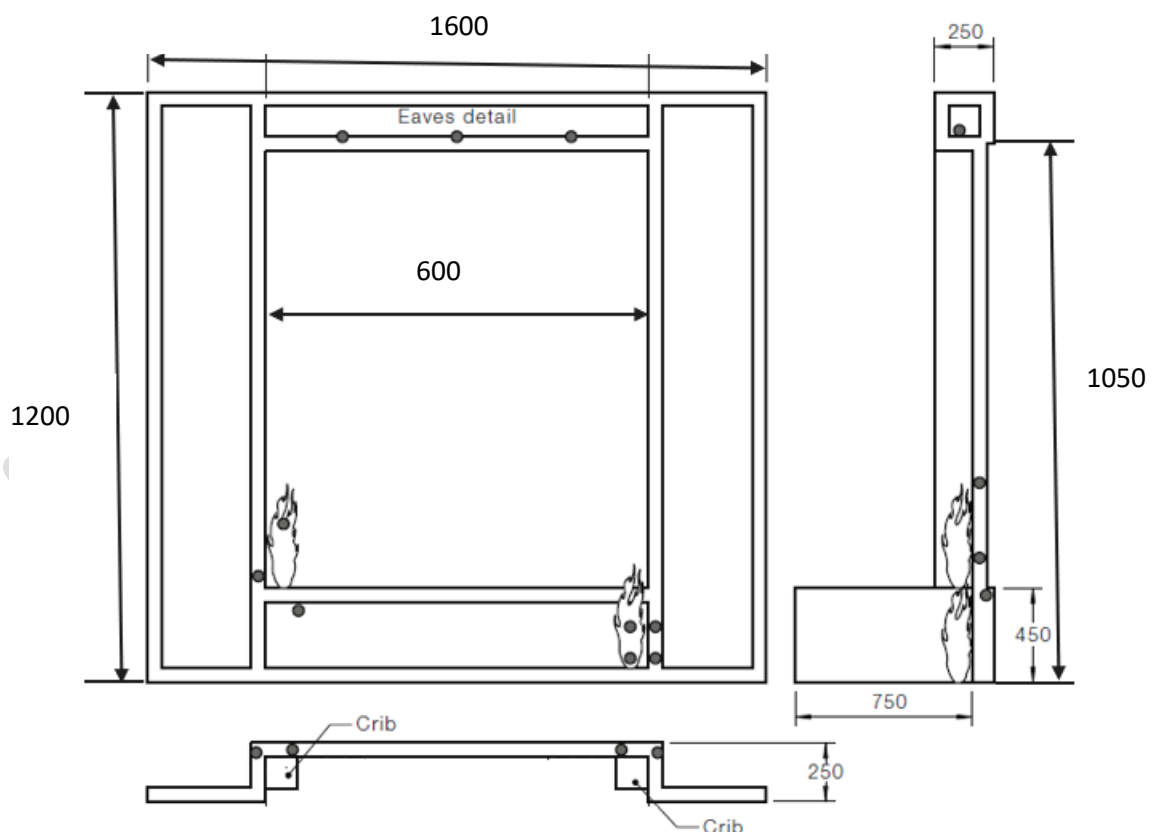
FIGURE 6:

The external wall was built to have rebate in the centre of the specimen with an eaves detail being 600 mm. The specimen deck was fabricated to fit the rebate of the external wall. The thermocouples on the eaves detail are 1050 mm above the ground. The test configuration for deck assemblies was shown below.

THE TEST CONFIGURATION FOR DECK ASSEMBLIES (NO CRIB WAS PLACED UNDER THE DECKING)

● = Incipient fire spread thermocouples

Note: In this test, the second crib at the bottom is not applied.

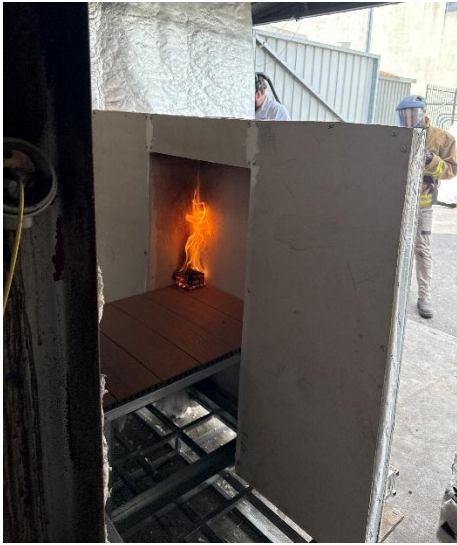
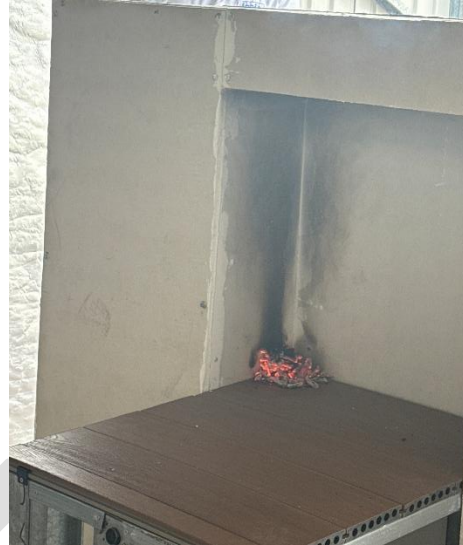
FIGURE 7:

| 01:00 minutes | Light smoke was observed from the top of the specimen. |
| 04:00 minutes | Small melting and bubbling were observed on the front edge of the deck. |

SPECIMEN 1 MIN INTO THE TEST

SPECIMEN 5 MINS INTO THE TEST

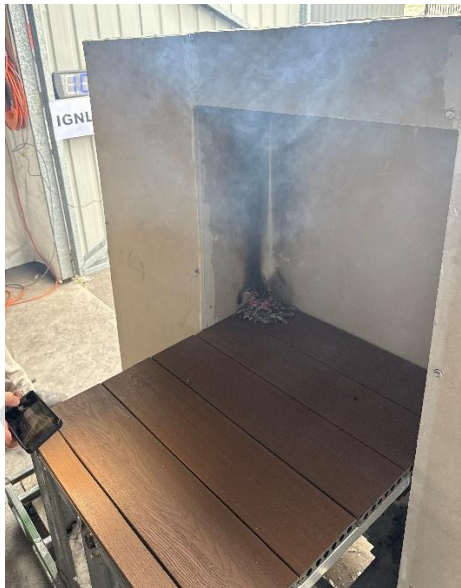
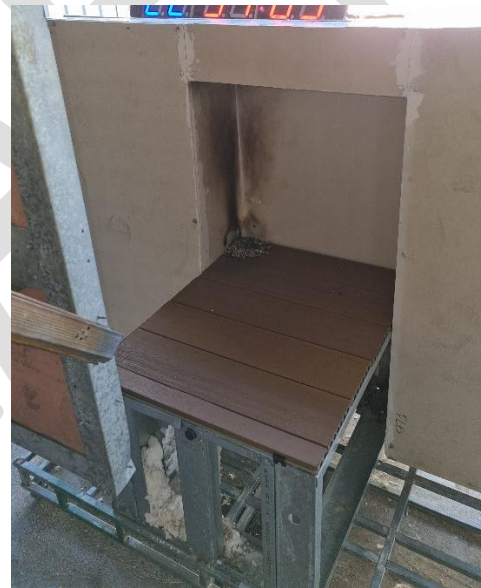
FIGURE 8:

| 10:00 minutes | Door closed. Light smoke and glowing embers were observed from the crib. |

SPECIMEN 10 MINS INTO THE TEST

SPECIMEN 40 MINS INTO THE TEST

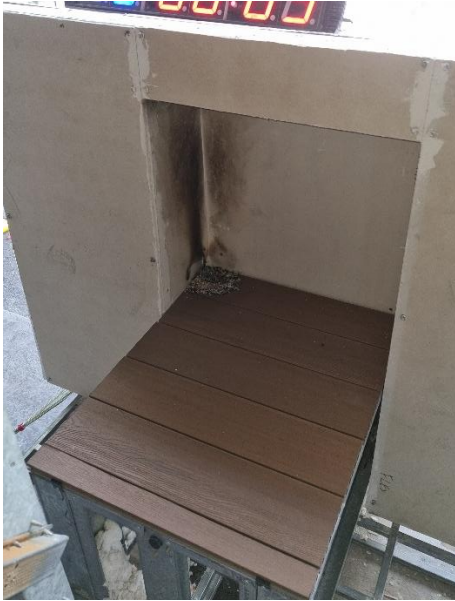
FIGURE 9:

| 60:00 minutes | Test end. |

END OF THE TEST – 60 MINS

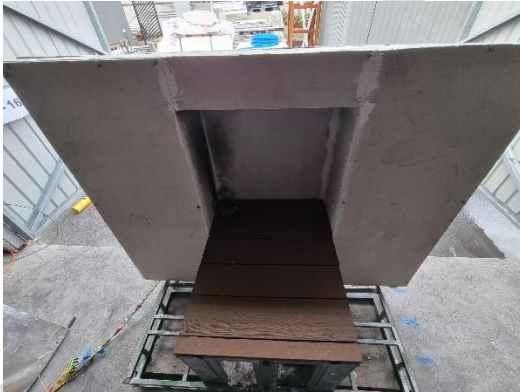
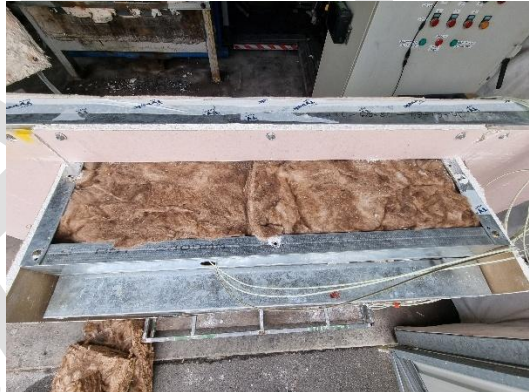
FIGURE 10:

POST TEST SPECIMEN – EXPOSED FACE

POST TEST SPECIMEN – UNEXPOSED FACE - TOP

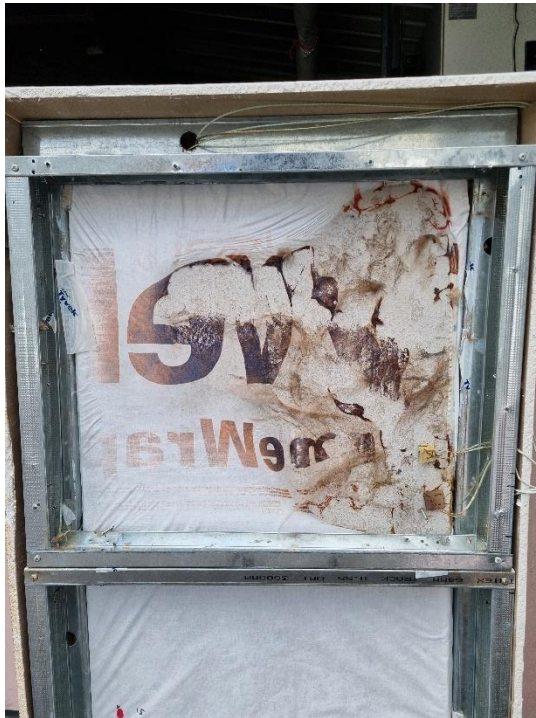
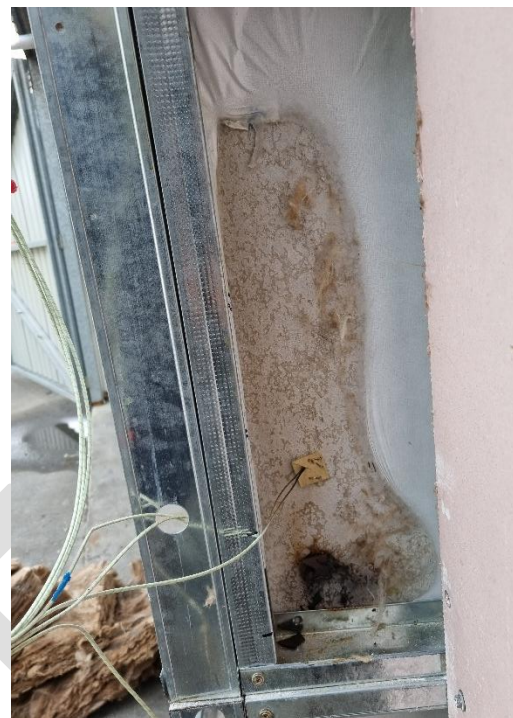
FIGURE 11:

POST TEST SPECIMEN – UNEXPOSED FACE

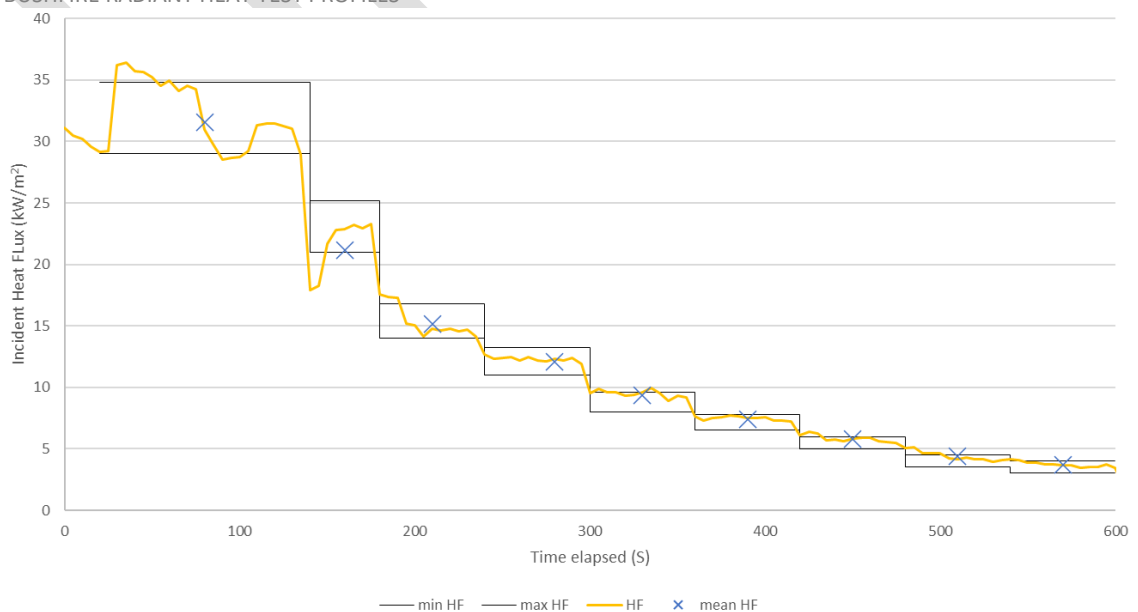
FIGURE 12:

The furnace temperature and radiant panel was controlled so that the average heat flux, measured at the centre of the panel was maintained within the prescribed radiant heat flux limits in accordance with Table 14.2 of AS 1530.8.1-2018.

The following figure shows the radiant heat test profiles. The mean heat flux measured is within the required range.

BUSHFIRE RADIANT HEAT TEST PROFILES

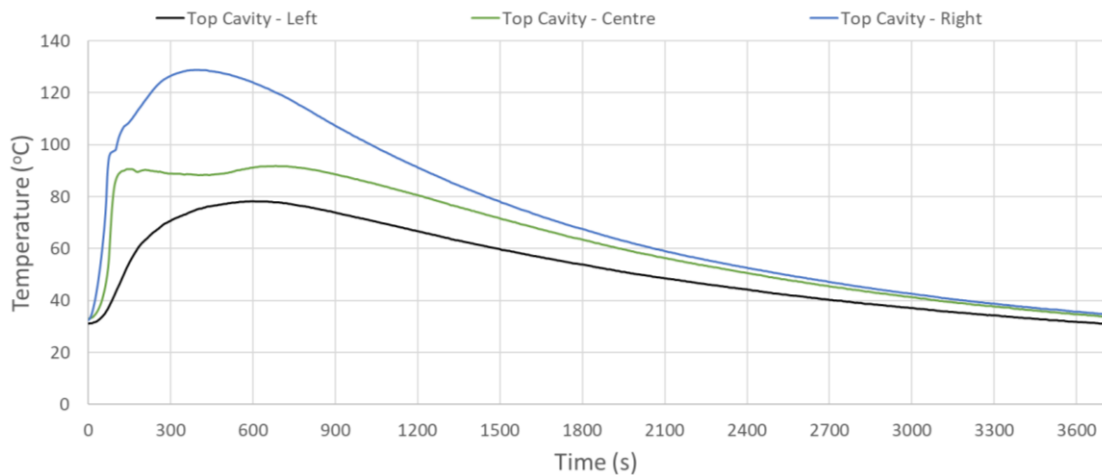
FIGURE 13:

THERMOCOUPLE TEMPERATURES AT THE TOP CAVITY

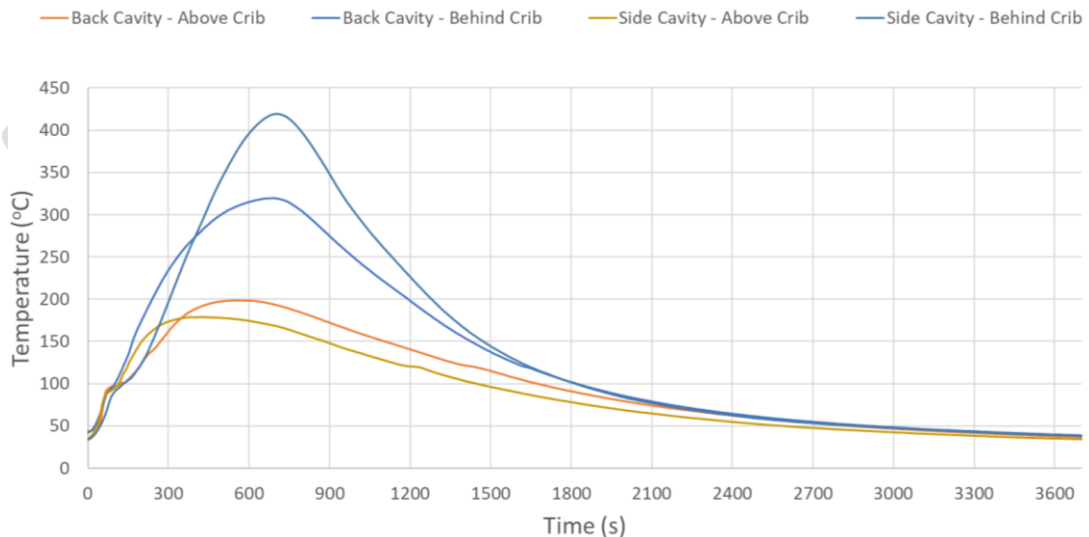
FIGURE 14:

All thermocouple temperature at the back cavity is within the mean and maximum temperature limits between 20 min and 60 min after commencement of test.

THERMOCOUPLES TEMPERATURES AT THE BACK CAVITY
